# Manhole Inspection Summary

Manhole # **S41KK\_038MH**

Insp Date: **1/22/08 2:43 PM**

**Location** Address: **1300 LAFAYETTE AVE**

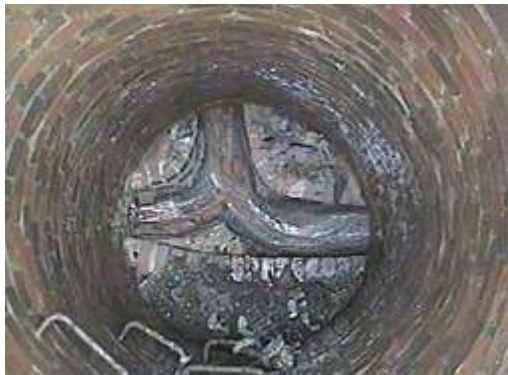
Defect 2

**Steps** Count: **6** Missing: **0** ☒ **Corroded**

STEPS CORRODED

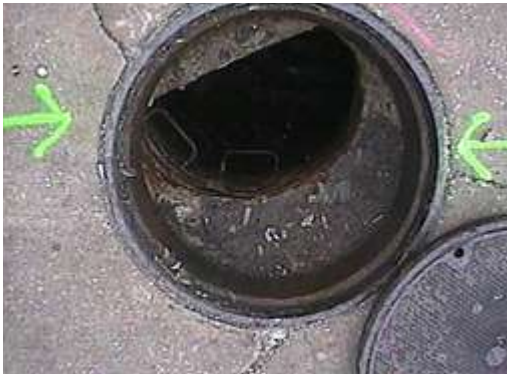
Defect 1

**Frame** Offset: **10** (in.) Condition: ☒ Sound ☐ Cracked ☐ Leaks

FRAME OFFSET

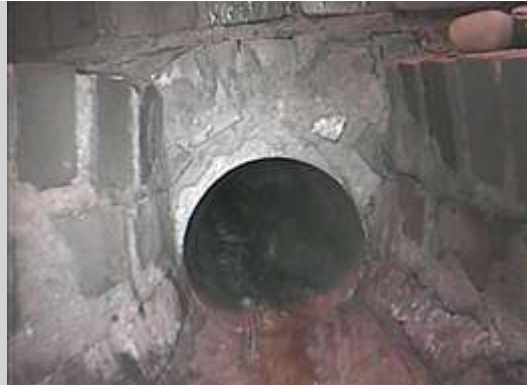
12 O'Clock Outflow

Pipe Height: (in.) Direct  
Pipe Material: **Clay** ☐ Pipe Lined  
Invert Depth: **10.70** (ft.) Flow Characteristics: **Fast**  
Deposits: ☒ None ☐ Mud ☐ Sludge ☐ Debris ☐ Grease  
Silt Depth: (in.) Deposits Extent:  
Infiltration: **None** Pipe Seal Cond: **Sound**

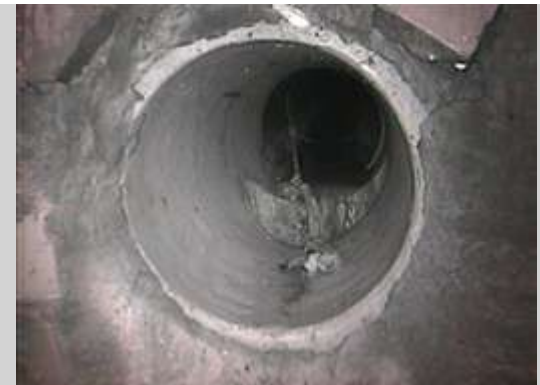
3 O'Clock Inflow

Pipe Height: (in.) Direct  
Pipe Material: **Clay** ☐ Pipe Lined  
Invert Depth: **8.09** (ft.) Flow Characteristics: **Fast**  
Deposits: ☒ None ☐ Mud ☐ Sludge ☐ Debris ☐ Grease  
Silt Depth: (in.) Deposits Extent:  
Infiltration: **None** Pipe Seal Cond: **Sound**

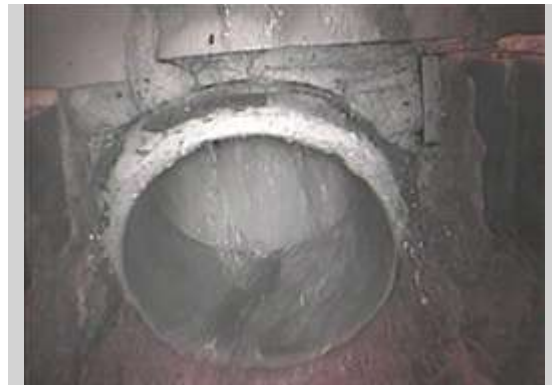
Drop In @ 3 O'Clock

Drop: **Outside Direct**  
Angled: Reading: (ft.)  
Inv Depth: **10.53** (ft.)  
Drop Condition: **Open**

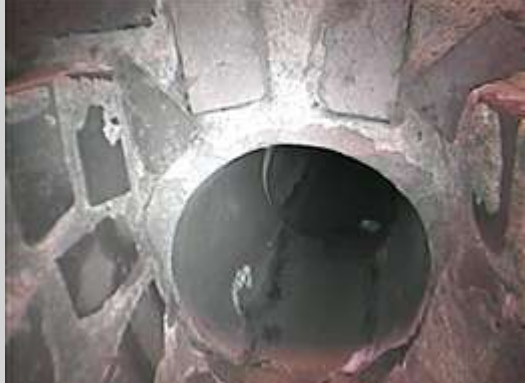
9 O'Clock Inflow

Invert Depth: **10.54** (ft.) Flow Characteristics: **Slow**

Infiltration: **None** Pipe Seal Cond: **Sound**
